**HAWKES BAY REGIONAL
COUNCIL**

**Wairoa River Bank Stability
Assessment**

Report prepared by:
TONKIN & TAYLOR LTD

May 2009

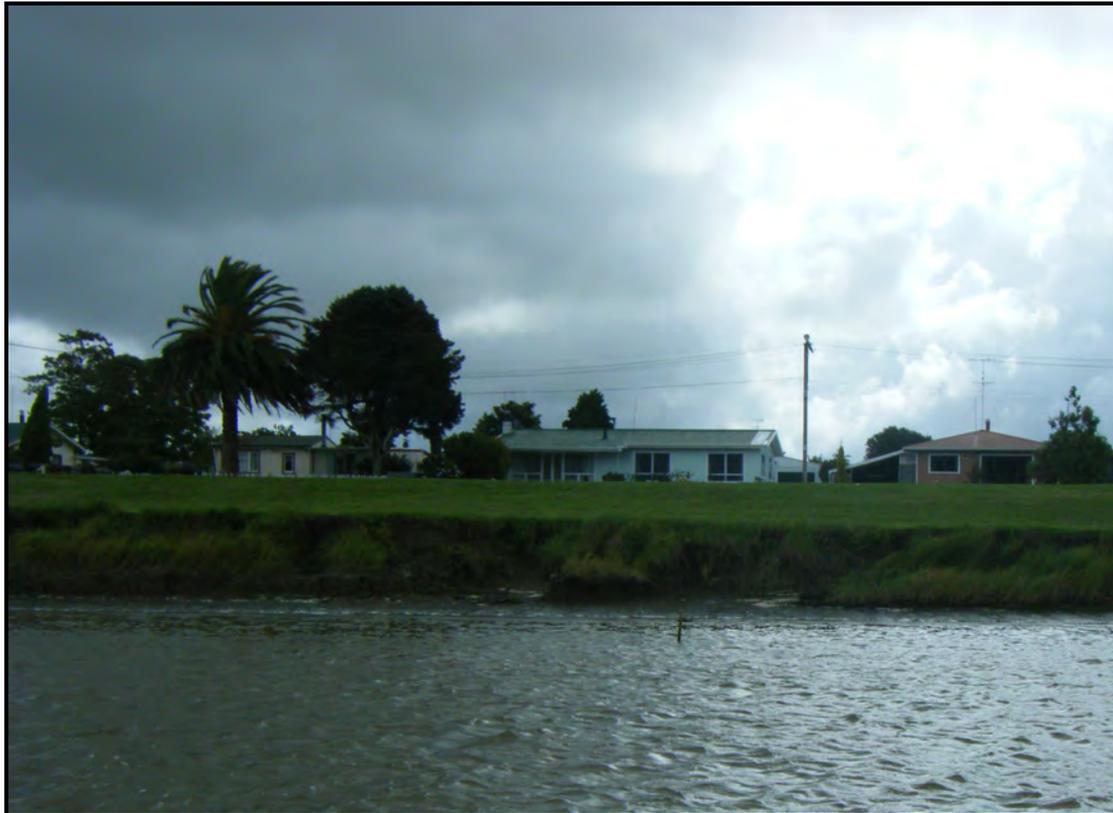
Photograph 1: Low, near vertical slopes adjacent to Kopu Street.

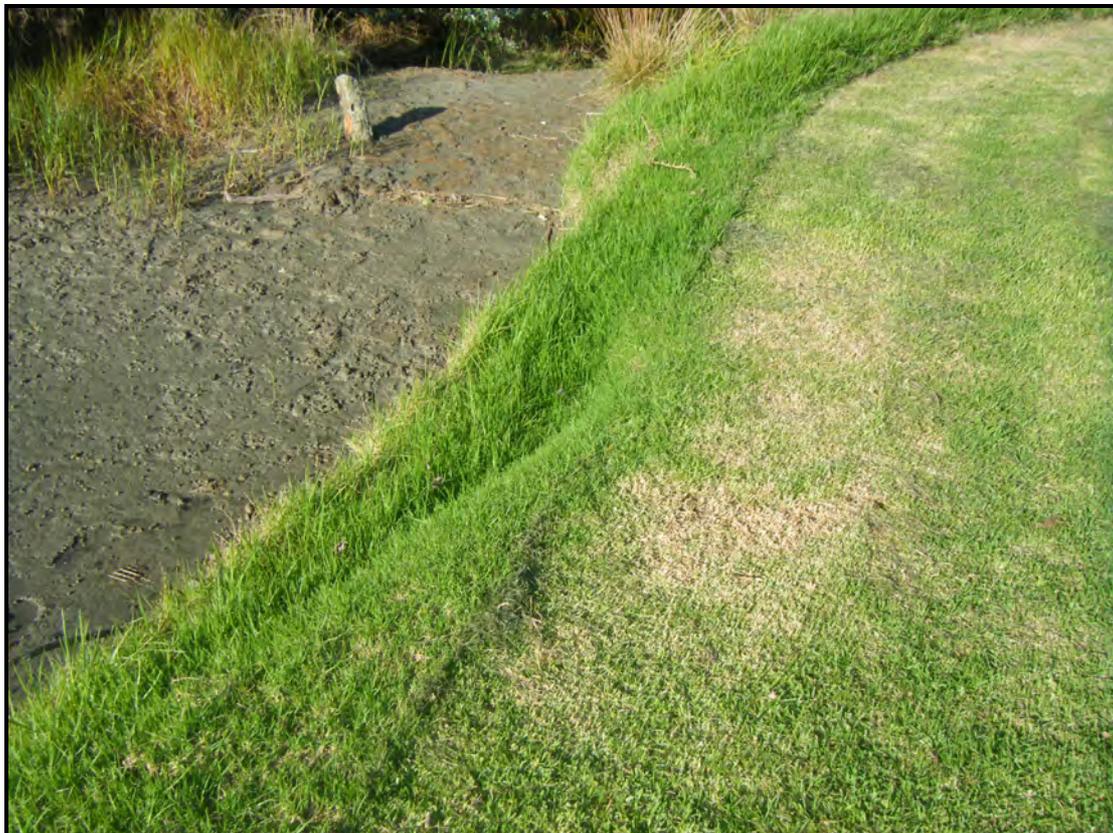
Photograph 2: Narrow failures of near vertical river banks at southern end of Kopu Street.

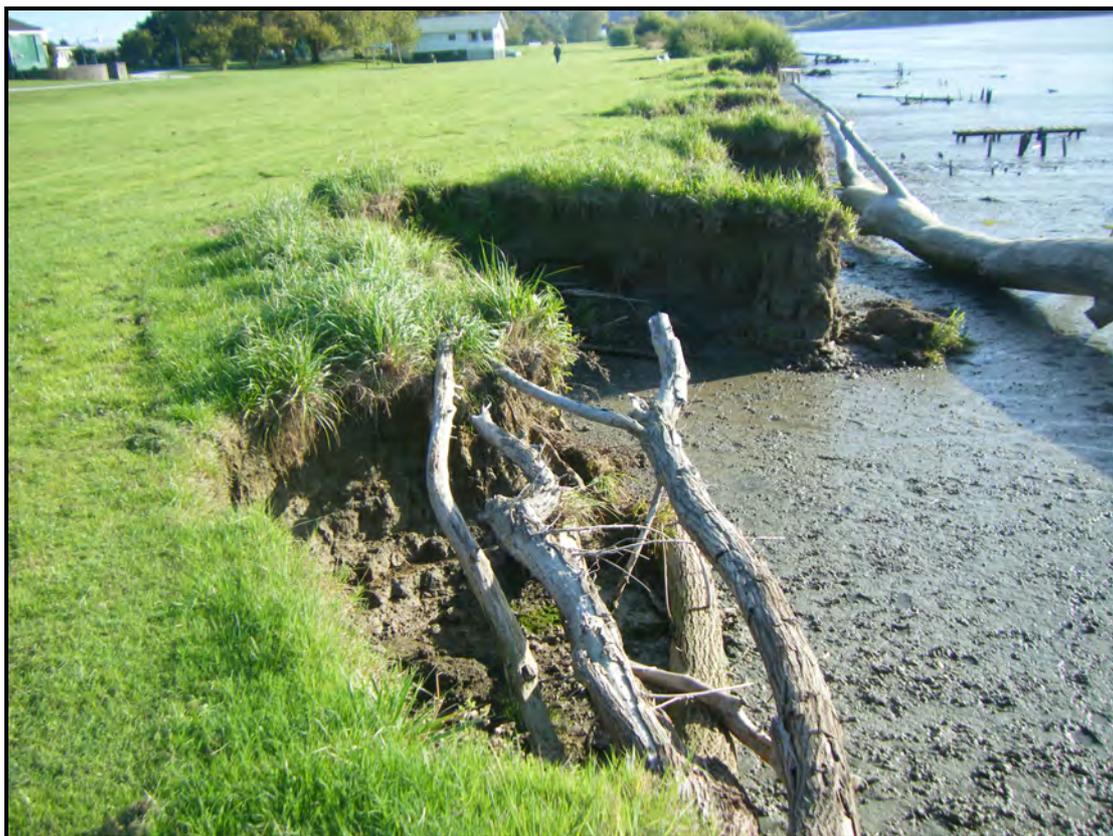
Photograph 3: Rotational failures of near vertical river banks along southern end of Kopu Street.

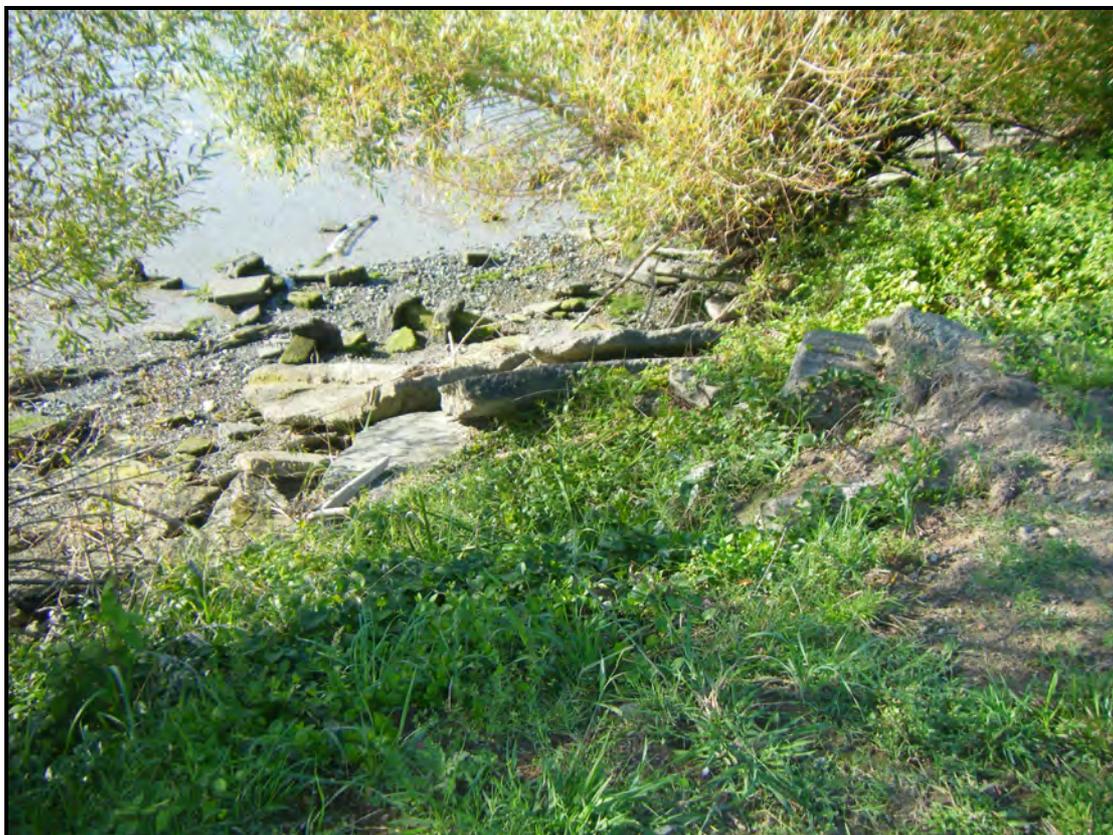
Broken concrete slabs and other man-made materials have been pushed over the edge of the bank in areas between Grey Street and Sturdee Street (see Photographs 4 and 5) and act as an ad hoc bank defence, but are unlikely to provide any medium- to long-term protection. No existing engineered protection measures were observed along this section.

Photograph 4: Broken concrete pushed over river bank in area of Grey Street / Sturdee Street.

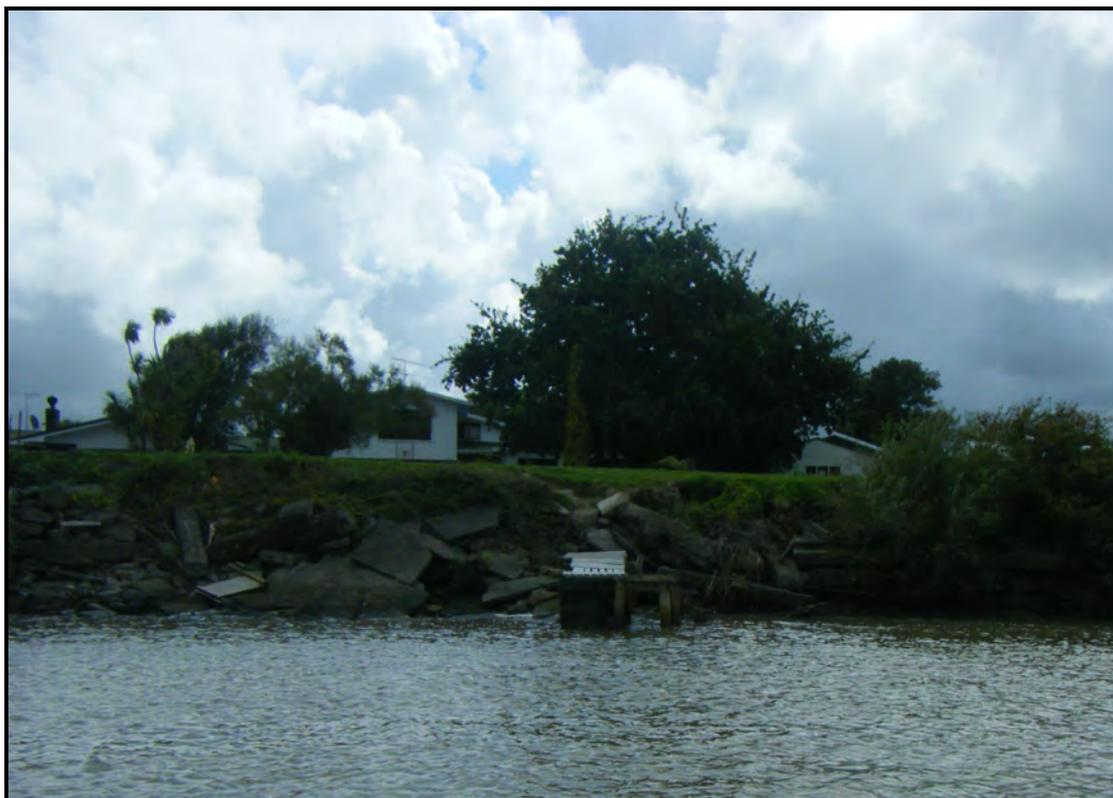
Photograph 5: As Photograph 3, taken from river.

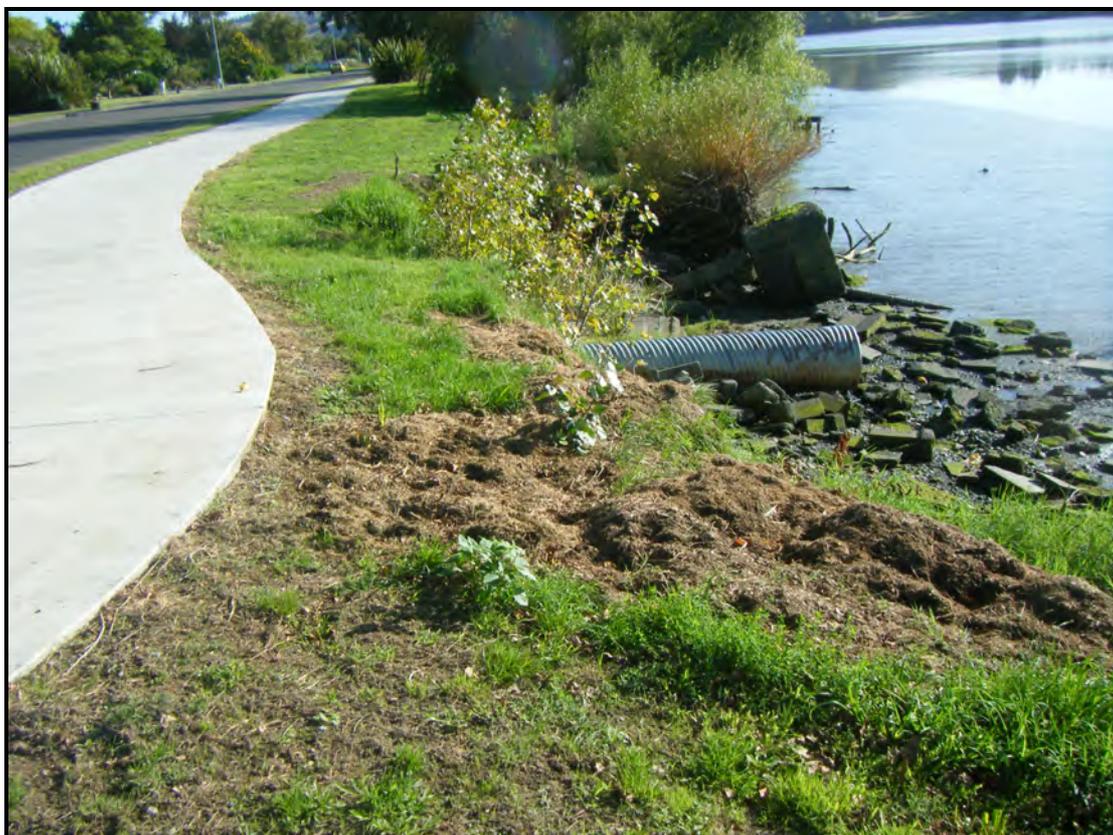
Photograph 6: River bank adjacent to Kopu Road and surfaced footpath in the area of Sturdee Street.

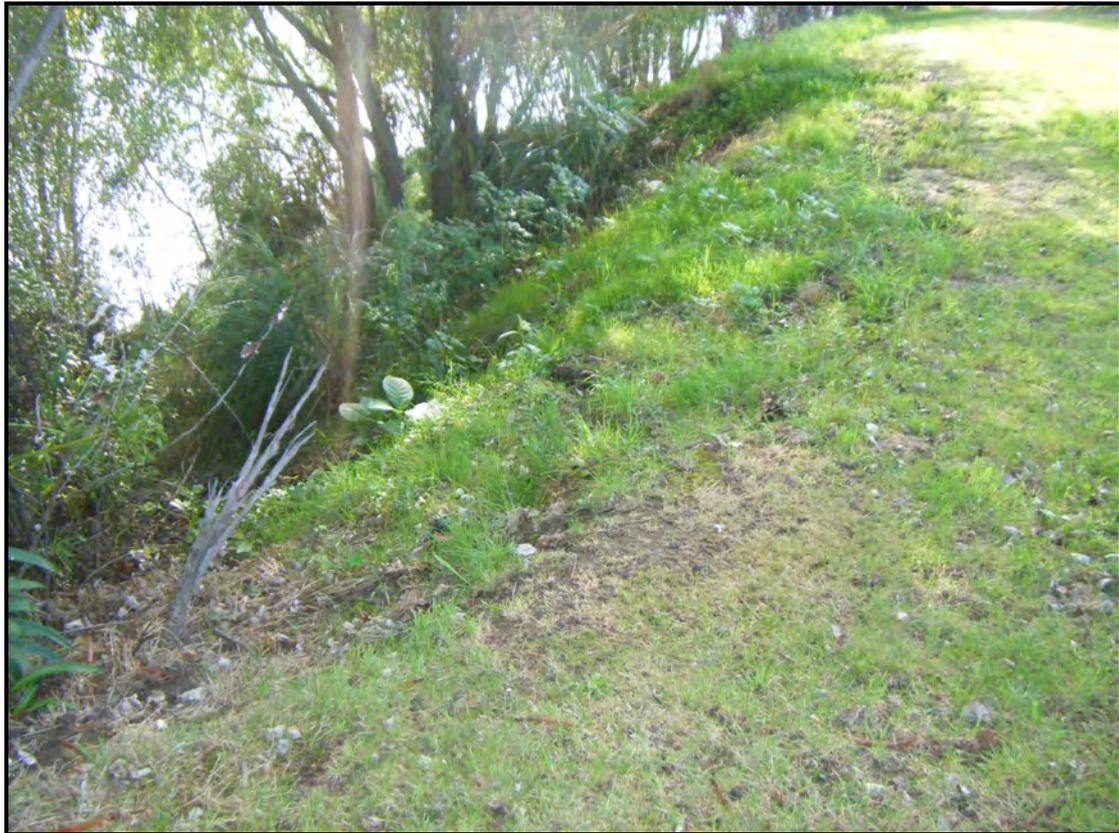
Photograph 9: Shallow instability of slopes at eastern end of Section 2.

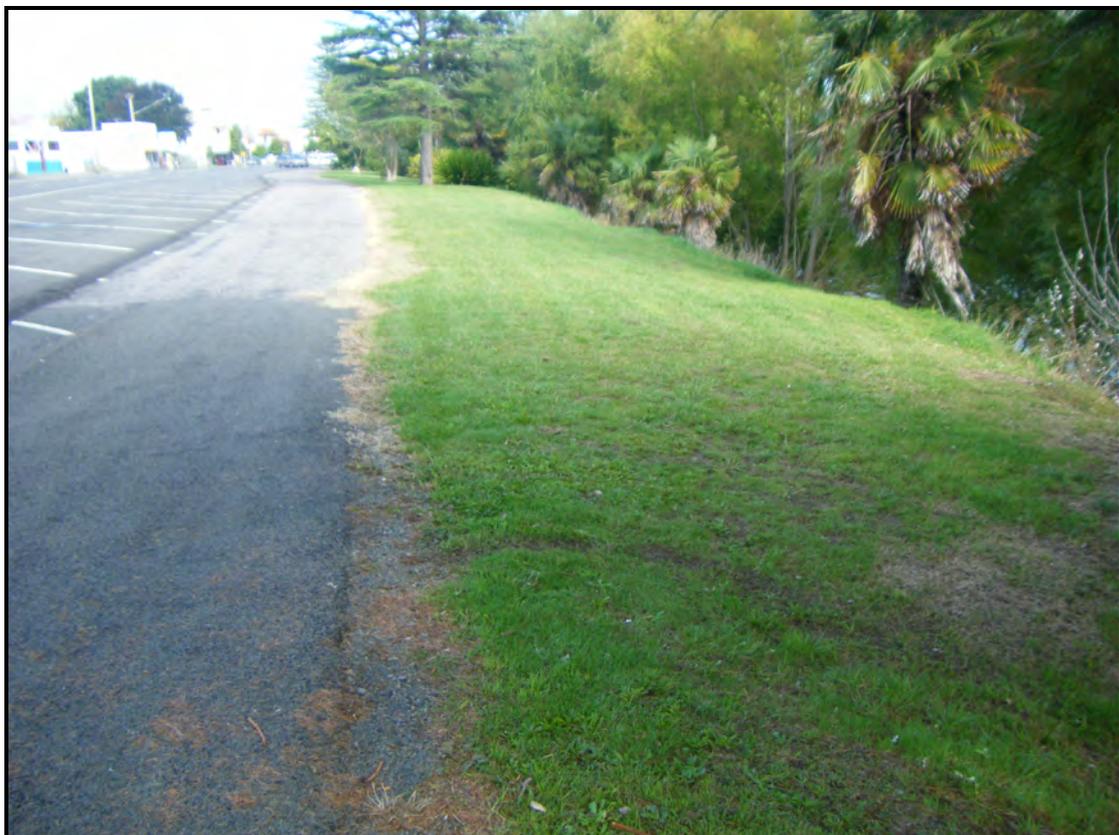
Beyond Murrae Street the slopes continue to be around 4 to 5m high but become heavily vegetated with well-established mature trees and thick bushes (see Photograph 10). The slopes are typically a little steeper (25 to 35°) and lack the defined bench observed to the east, although there is a rough footpath along much of the slope which has been terraced into the bank. There are further signs of scour of the river banks (see Photograph 11) but less instability of the high slopes, or these may be masked by the relatively thick vegetation.

Photograph 10: Facing west along river bank adjacent to Marine Parade close to Delhi Street.

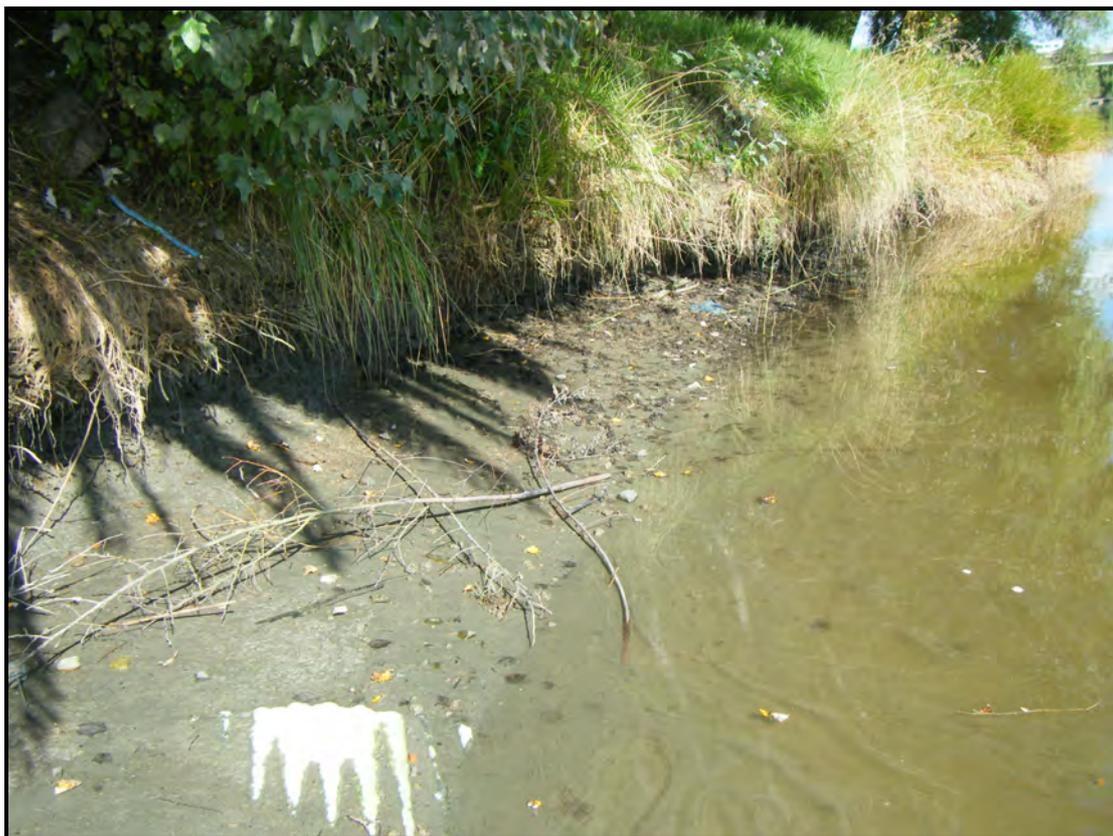
Photograph 11: Scour of river bank adjacent to Marine Parade close to Locke Street.

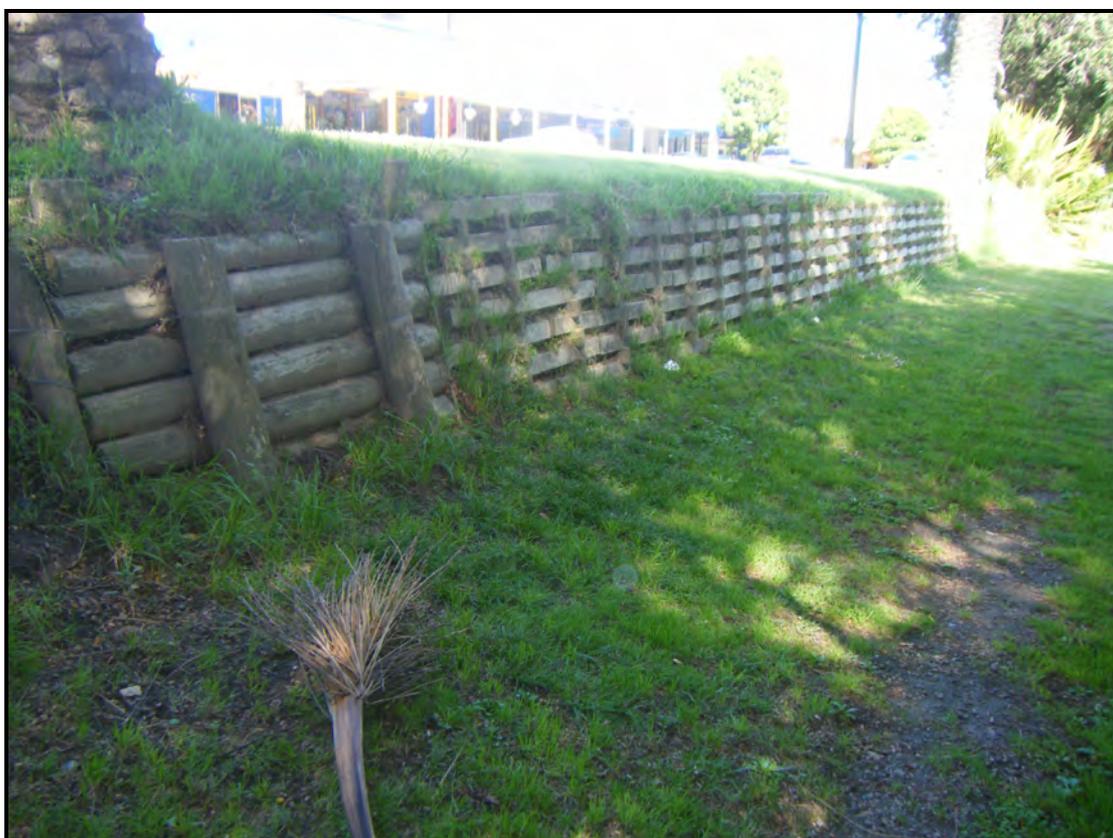
There are a number of 'engineered' retaining walls along parts of the upper slopes (see Photographs 12 to 14), but these generally appear to have been installed to retain sections of the bank that have been terraced for amenity or landscaping purposes, rather than in response to natural slope failures induced by fluvial processes. No engineered bank protection measures were observed at the toe of the slopes over this section of the river.

Photograph 12: 'Engineered' retaining wall on upper part of slope adjacent to Marine Parade close to Locke Street.

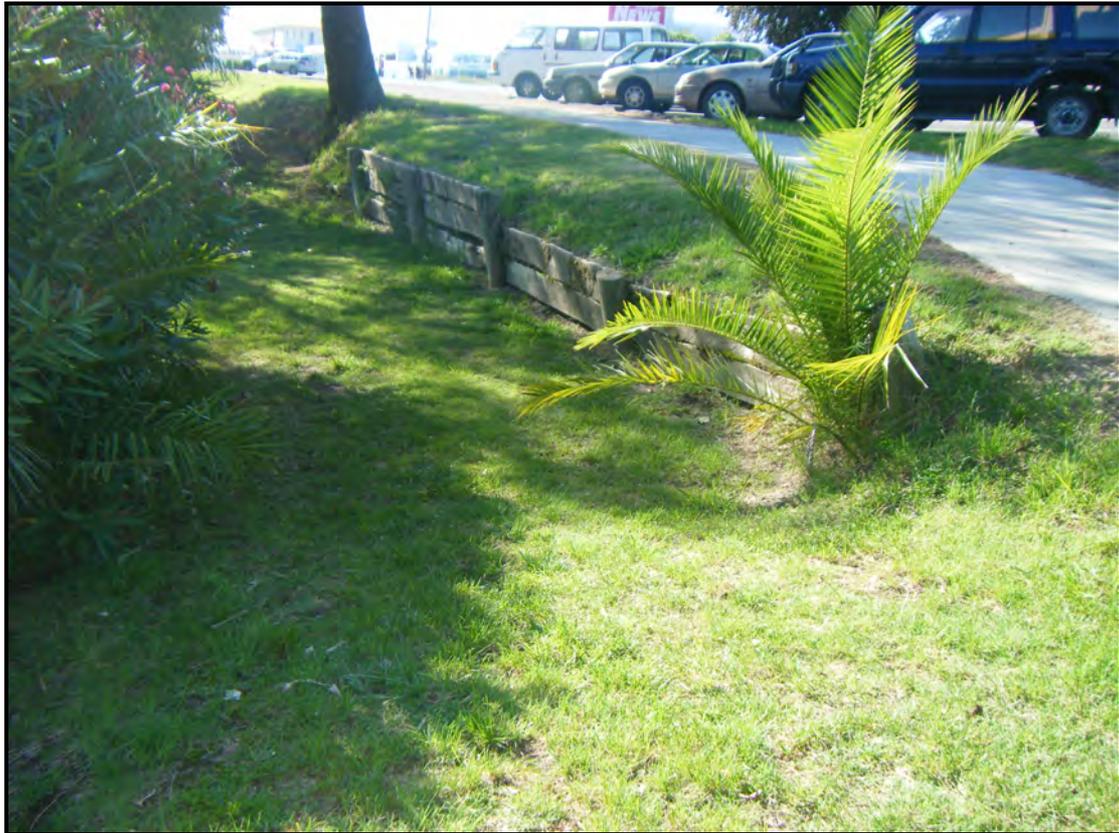
Photograph 13: ‘Engineered’ retaining wall on upper part of slope adjacent to Marine Parade.

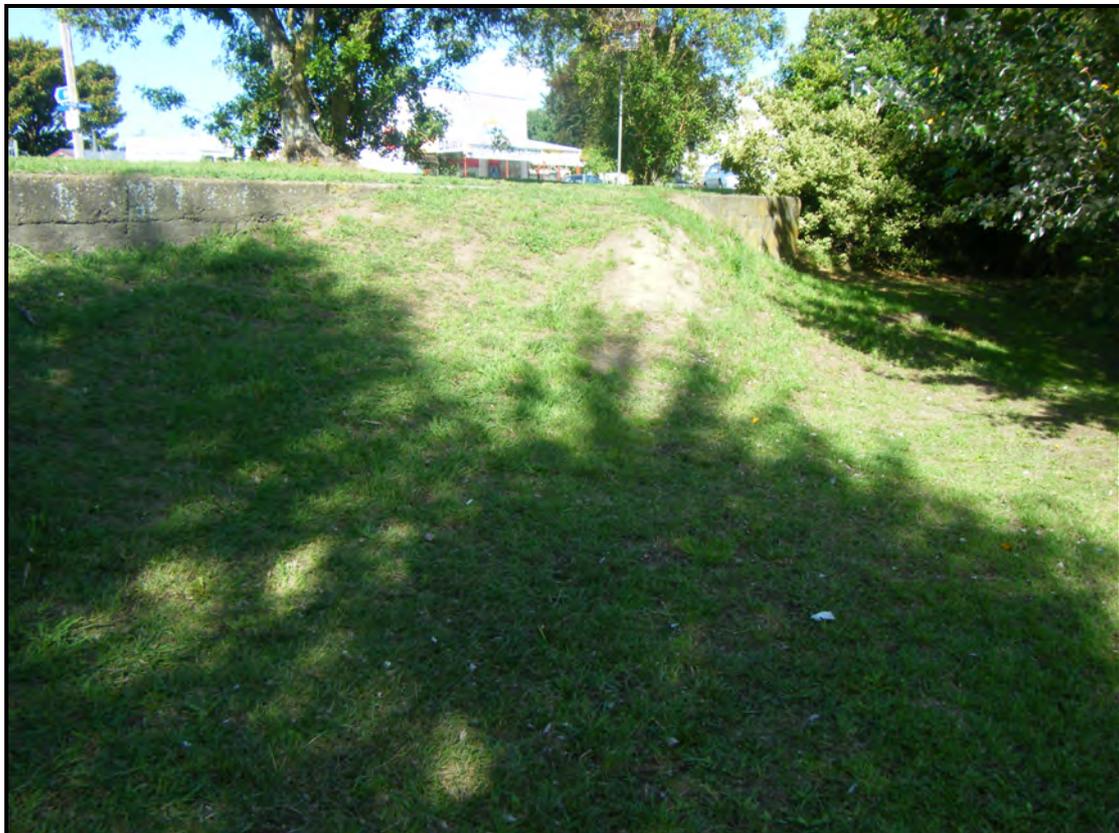
Photograph 14: ‘Engineered’ retaining wall on upper part of slope adjacent to Marine Parade.

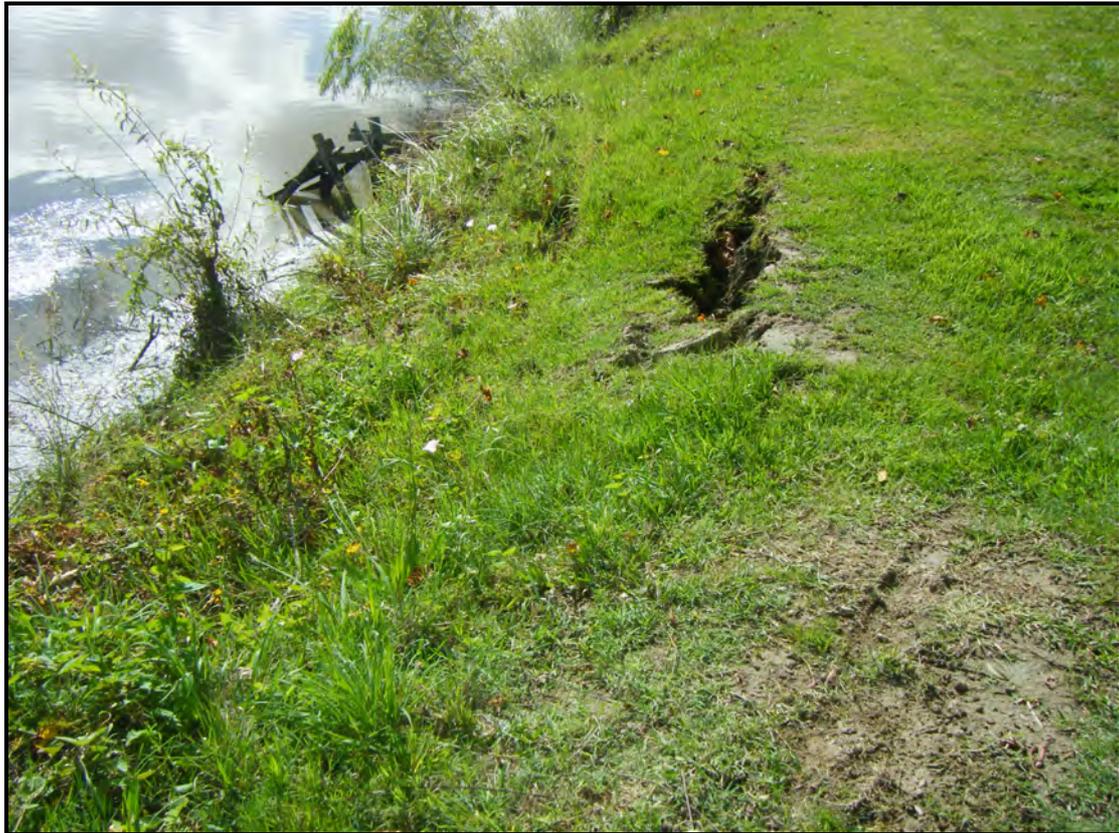
Photograph 19: Minor instability of river bank west of SH2 bridge, likely to have been initiated by ongoing scour and loss of toe support.

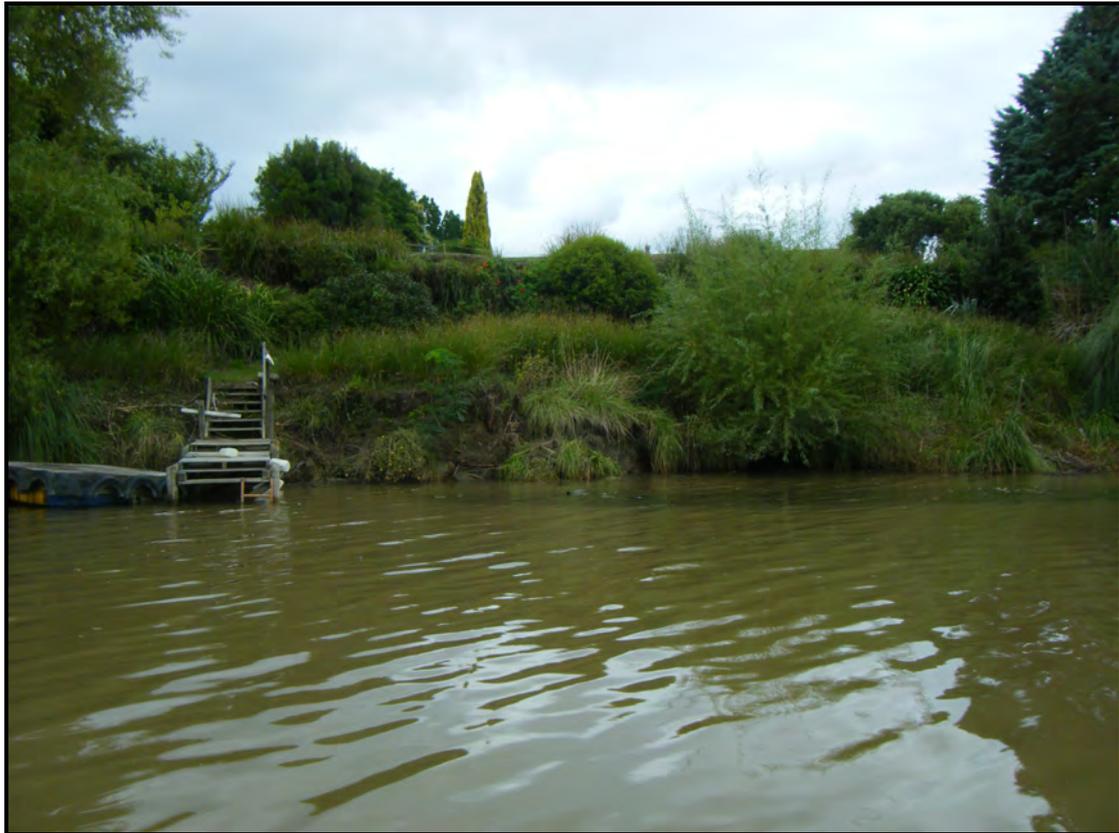
Photograph 21: Heavily vegetated slopes with signs of localised instability along right bank west of Churchill Street, at back of properties along Mitchell Road.

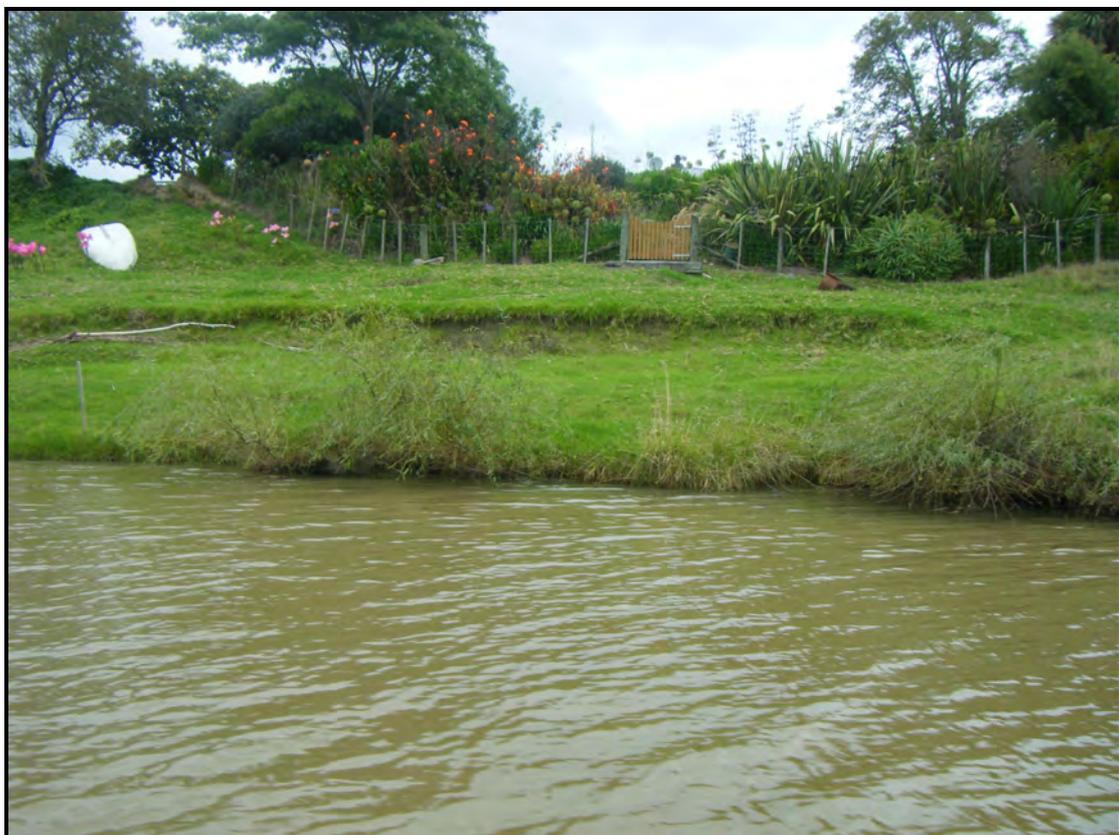
Photograph 22: Instability of slope beyond Mitchell Road.

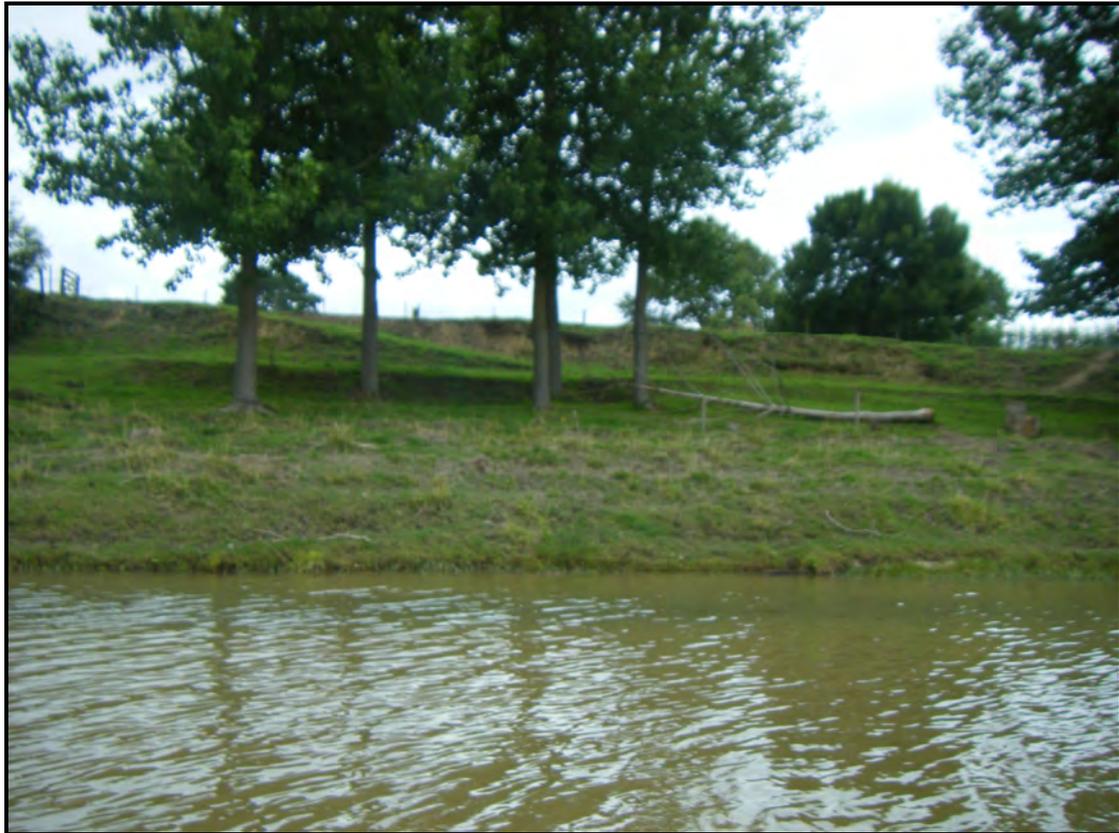
Photograph 23: Instability of slope beyond Mitchell Road.

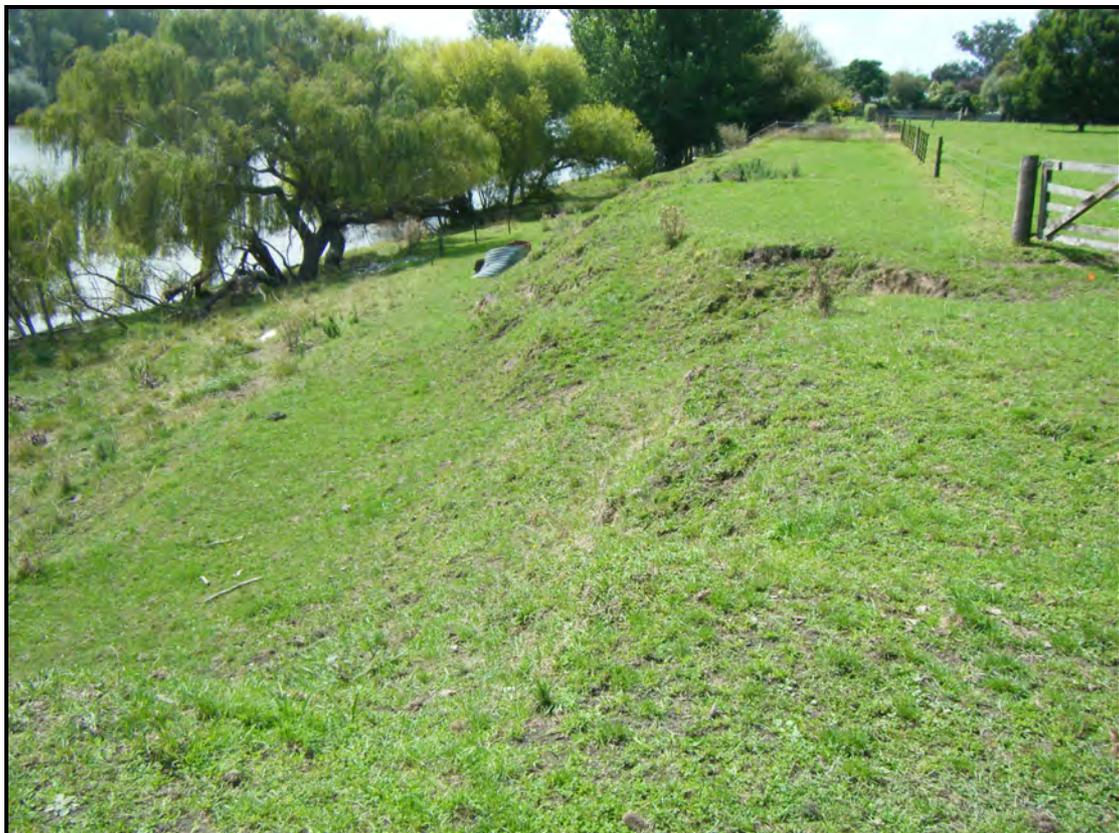
Photograph 24: Slope adjacent to SH2 at eastern end (adjacent to Section 4). This instability extends to the west but slope too heavily vegetated to show on photograph and determine extent.

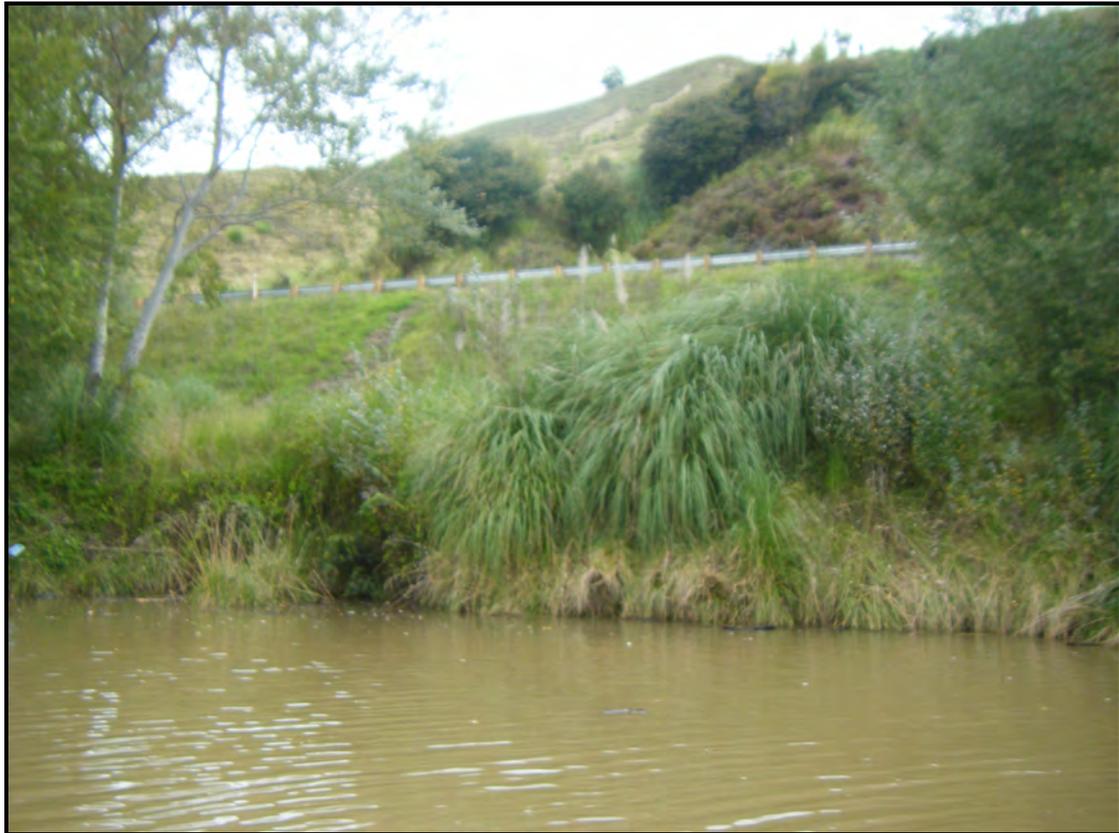
Photograph 25: Slope adjacent to SH2 with signs of recent instability and new crash barrier.

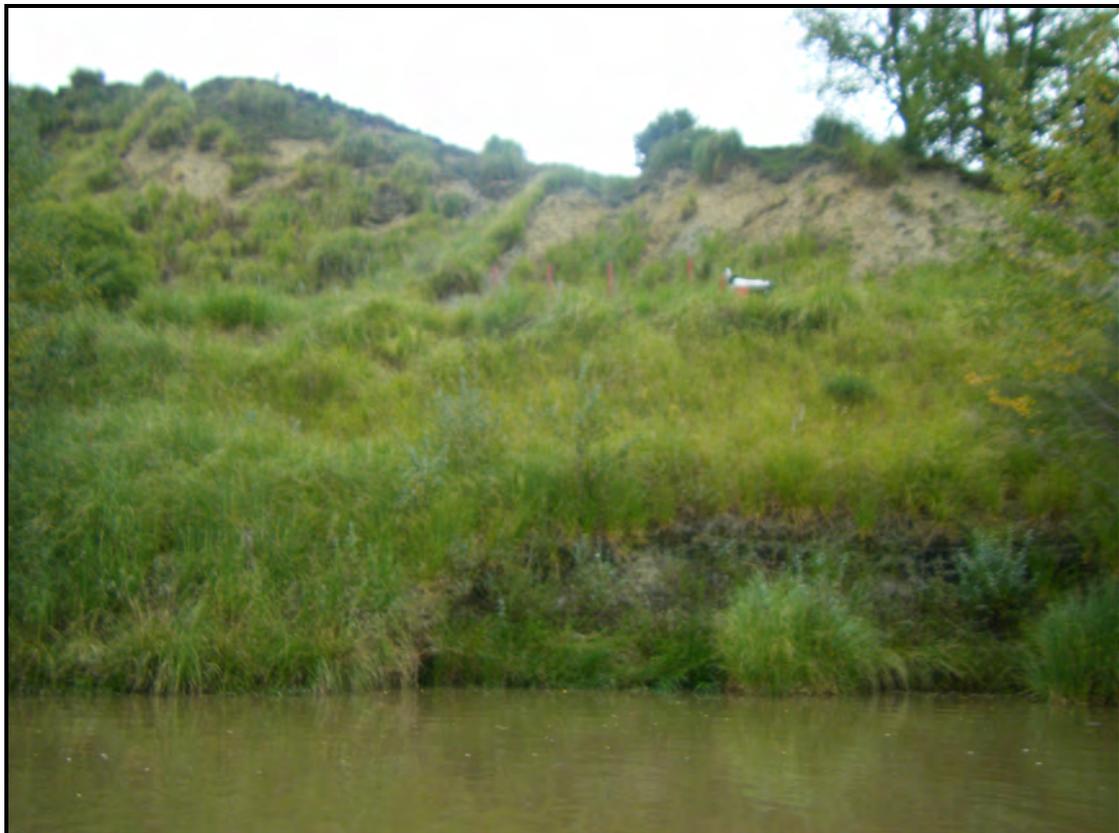
Photograph 26: Slope adjacent to SH2 with signs of recent instability of upper slopes and erosion with instability of lower river bank.

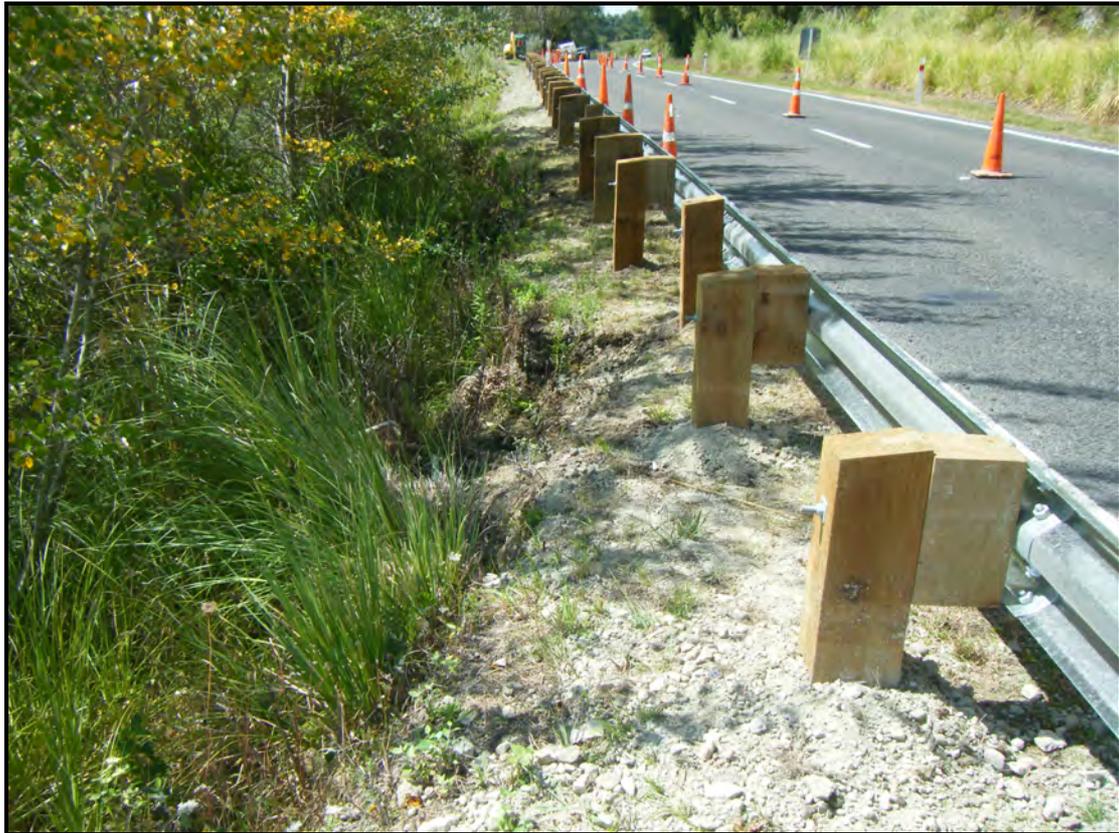
Photograph 27: Instability of upper part of 7 to 8m high slope adjacent to SH2 with new barrier recently completed.

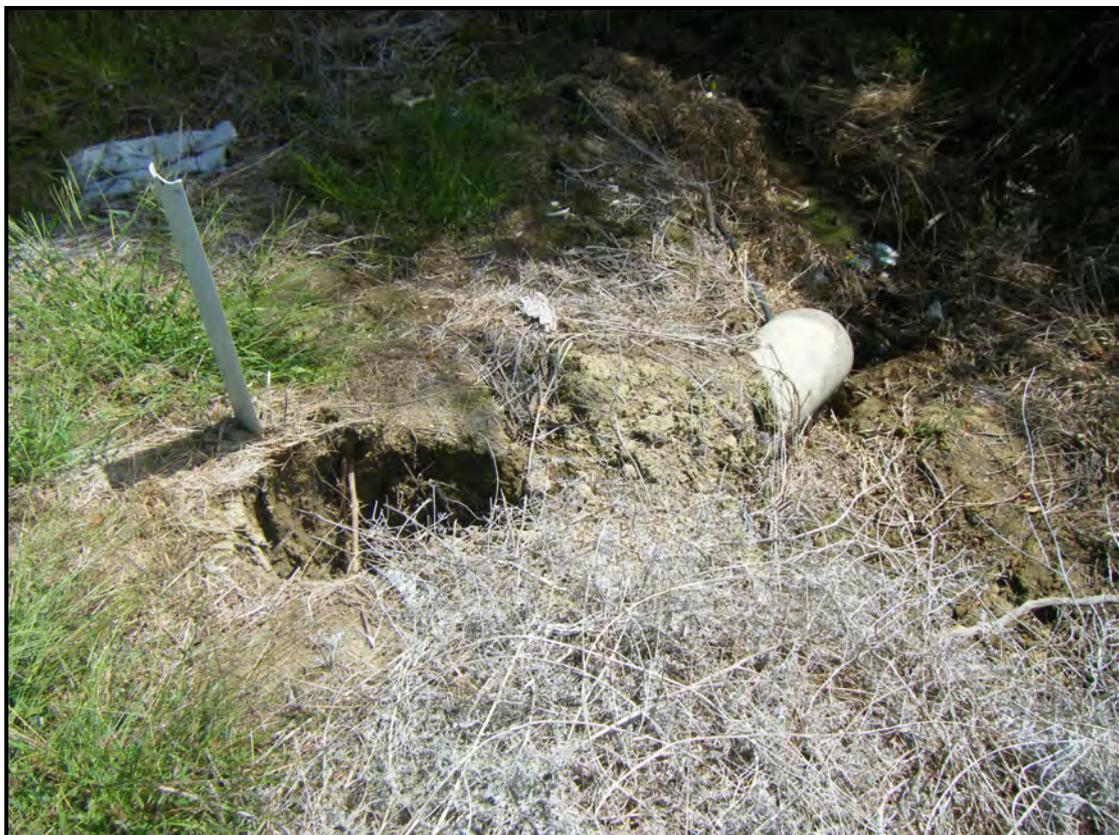
Some instability of the upper to middle sections of the slopes was observed resulting from surface water runoff, either directly from the road or via highway drainage. Some of the highway drains were observed to include sheeting placed over the surface of the slopes (see Photograph 28A). The majority however simply discharge out of a pipe located a short distance down the slope, which is resulting in erosion and subsequent localised instability of the slopes (see Photograph 28).

Photograph 28: Erosion and subsequent instability of slope adjacent to highway drainage outfall. Concrete pipe has collapsed and broken due to instability.

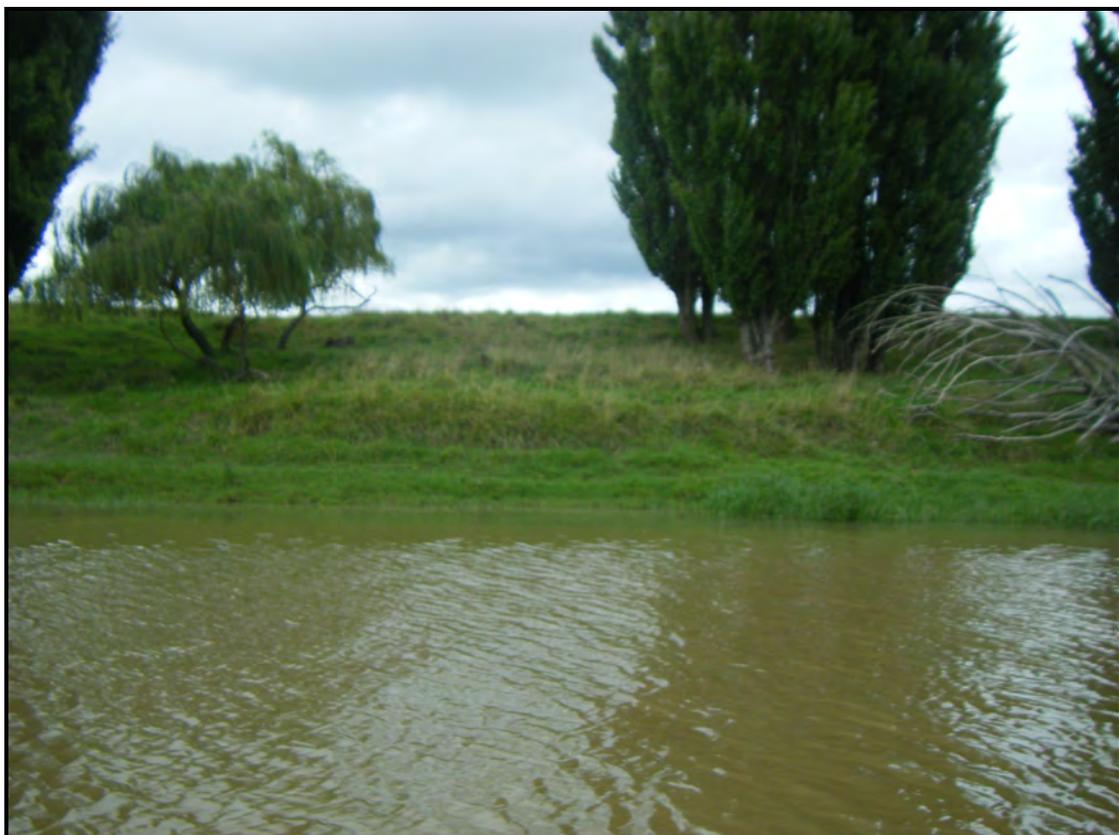
There are a number of relatively small landslips affecting the lower parts of the slopes below and just above the normal river level (see Photographs 29 and 31) and a few larger slips affecting a large part or all of the slope and extending some distance laterally (see Photograph 30). The larger failures appear to occur predominantly on the higher, steeper slopes within the central area of this section.

The relatively small slips located at the base of the slopes are likely to result predominantly from scour of the river bank and of are little significance in this area of the rivers reach. However, these failures may be precipitating larger failures affecting the upper slopes. The failures observed on the upper slopes, whilst only viewed from the boat, appear shallow and do not therefore take much of the above land.

Photograph 29: Instability of lower sections of lightly vegetated slope in Section 6.

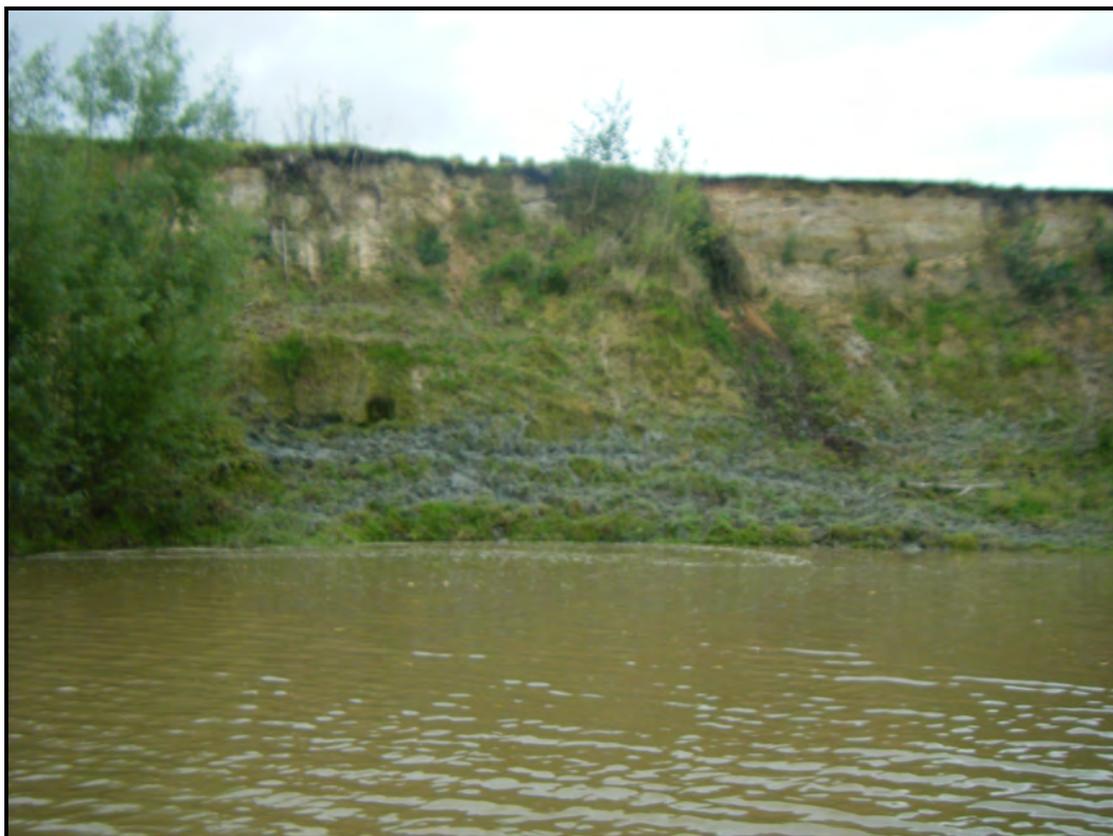
Photograph 30: Large scale instability of entire slope located within middle part of Section 6.
