**HAWKES BAY REGIONAL
COUNCIL**

**Wairoa River Bank Stability
Assessment**

Report prepared by:
TONKIN & TAYLOR LTD

May 2009

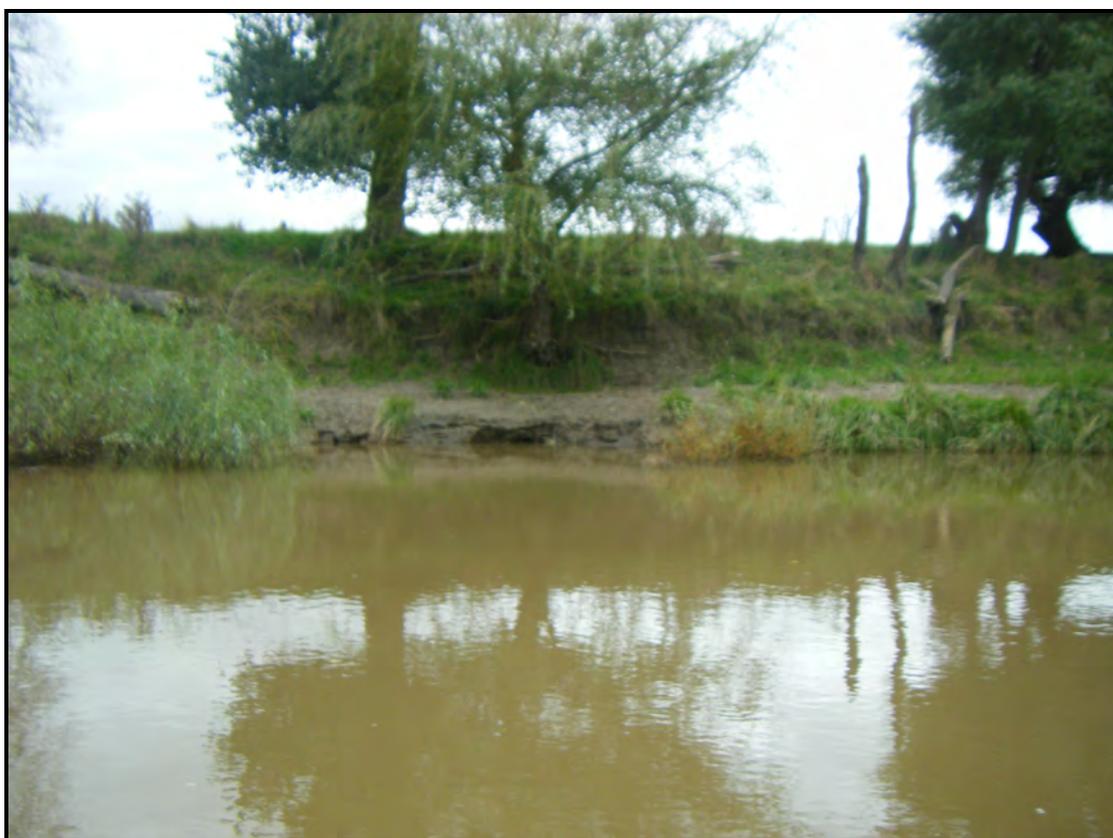
There are a number of relatively small landslips affecting the lower parts of the slopes below and just above the normal river level (see Photographs 29 and 31) and a few larger slips affecting a large part or all of the slope and extending some distance laterally (see Photograph 30). The larger failures appear to occur predominantly on the higher, steeper slopes within the central area of this section.

The relatively small slips located at the base of the slopes are likely to result predominantly from scour of the river bank and of are little significance in this area of the rivers reach. However, these failures may be precipitating larger failures affecting the upper slopes. The failures observed on the upper slopes, whilst only viewed from the boat, appear shallow and do not therefore take much of the above land.

Photograph 31: Scour induced instability of bank located at upstream end of Section 6.

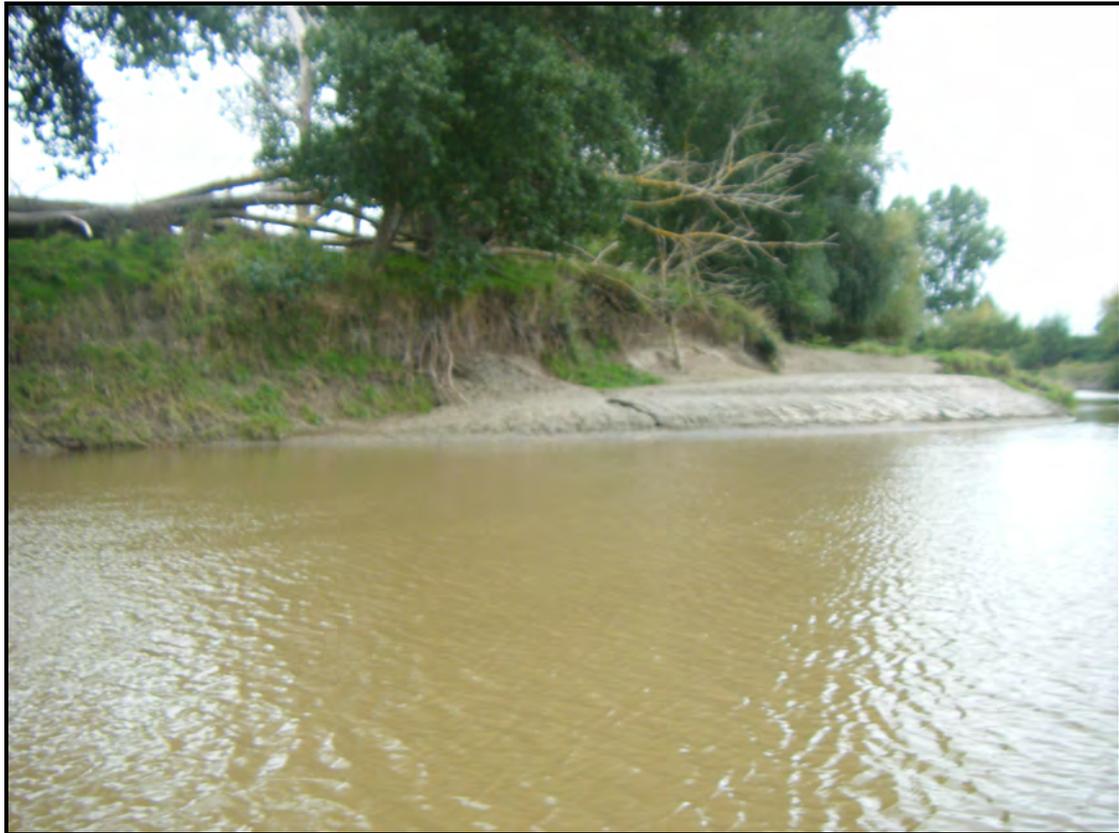
Photograph 32: Scour induced instability on inside bend of meander at upstream end of Section 6.

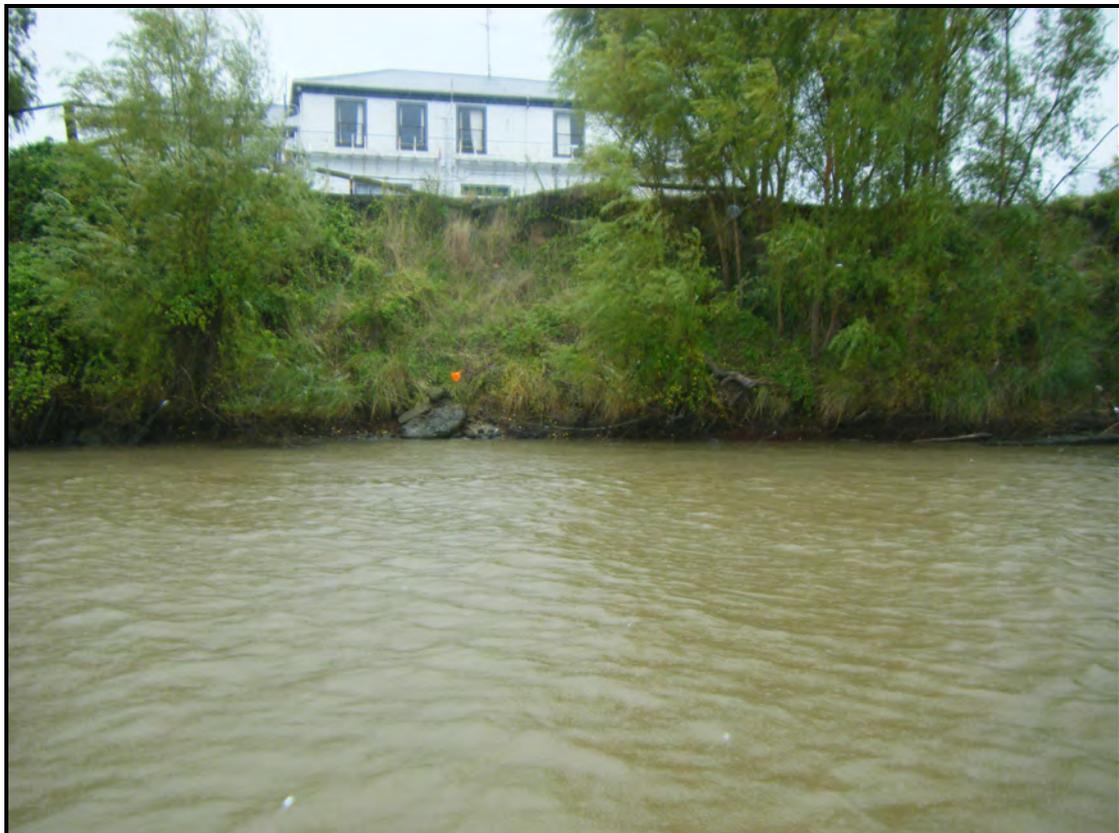
Immediately upstream of the SH2 bridge to the end of this section (a distance of approximately 0.5km), there are several quite large rotational failures affecting the entire slope (see Photographs 33, 35, 37 and 40). Some timber retaining walls have been constructed along the river bank in this area (see Photograph 36) and a concrete retaining wall (which has failed) on the upper part of the slope (see Photographs 38 and 39). It is noticeable that the river bank immediately upstream of the bridge forms a narrowing of the channel on the outside of the meander and therefore greater scour of the banks at this location might be expected.

Photograph 33: Instability of heavily vegetated slope upstream of SH2 bridge adjacent to former motel.

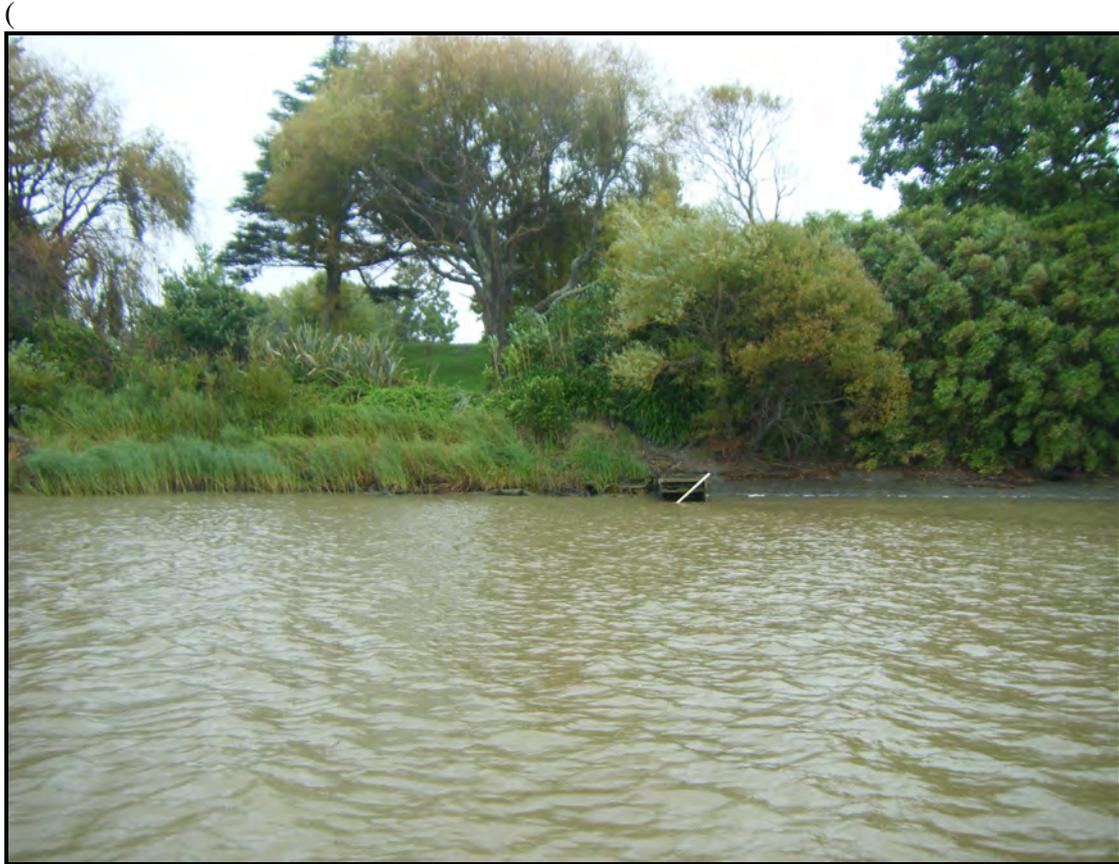
Photograph 34: Vegetated slopes downstream of SH2 showing some minor instability of river banks.

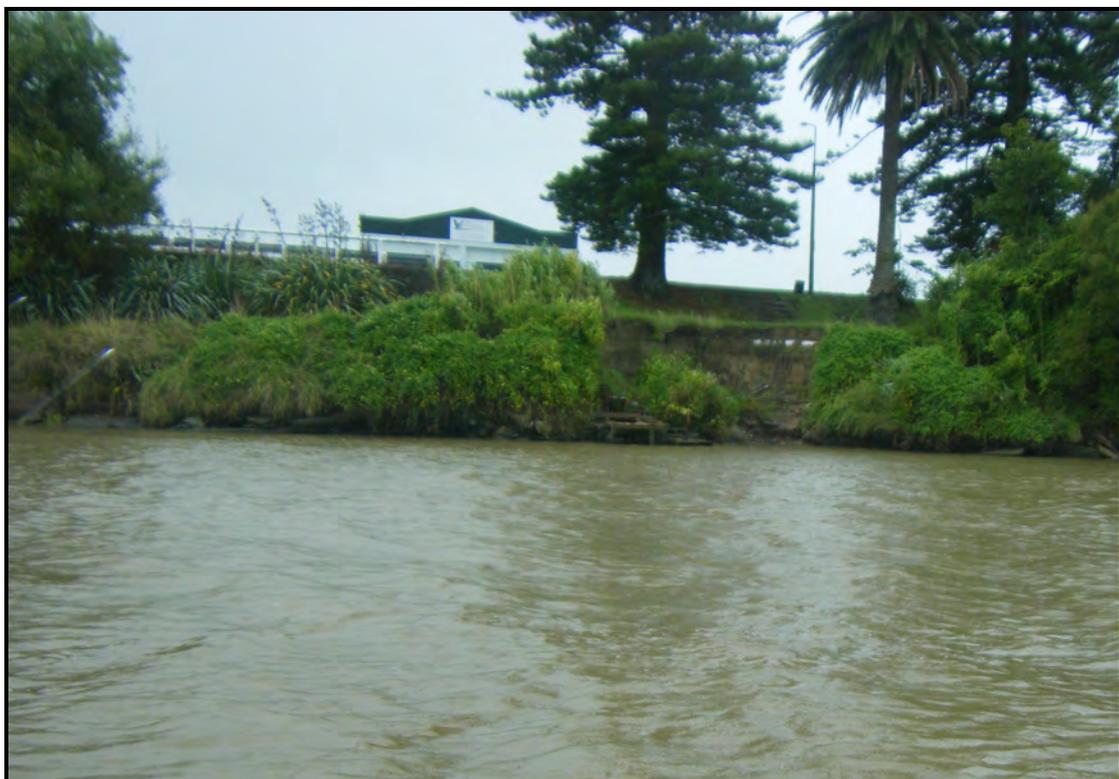
Photograph 35: Large rotational failures adjacent to River Parade immediately upstream of SH2 bridge (see also Photograph 37 below).

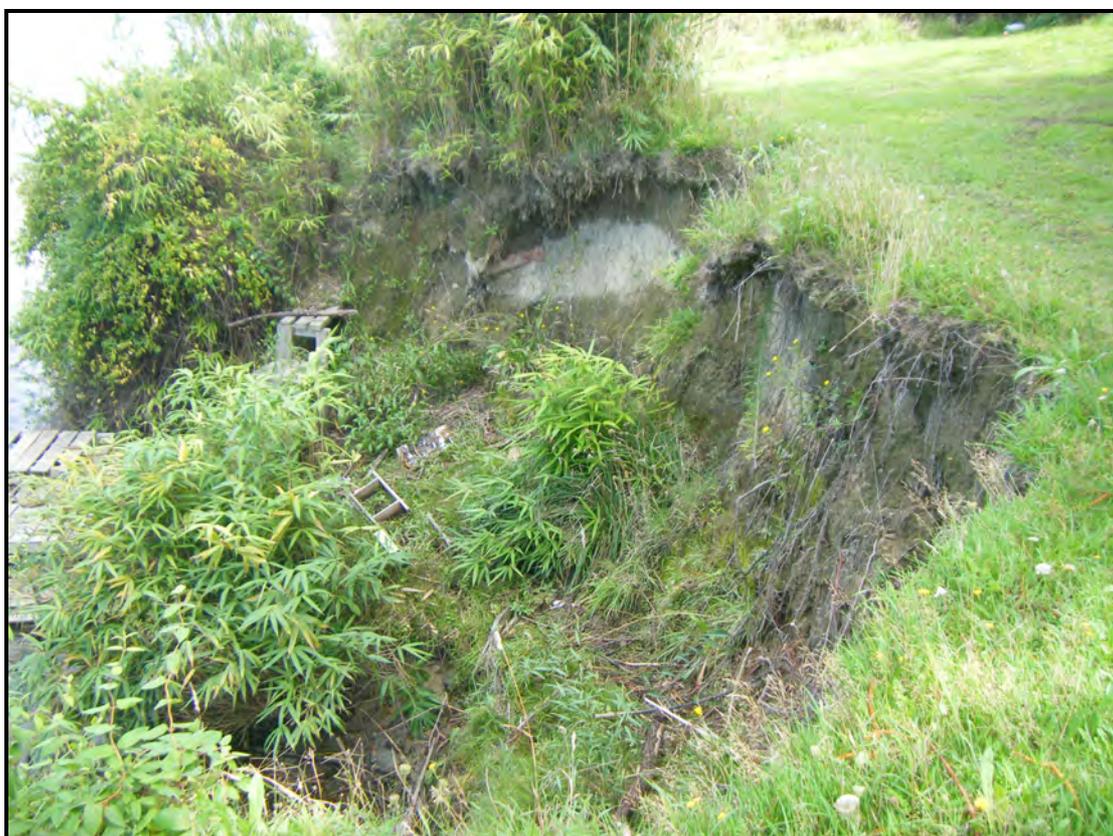
Photograph 37: Rotational failure of slope as shown from river in Photograph 35 above.

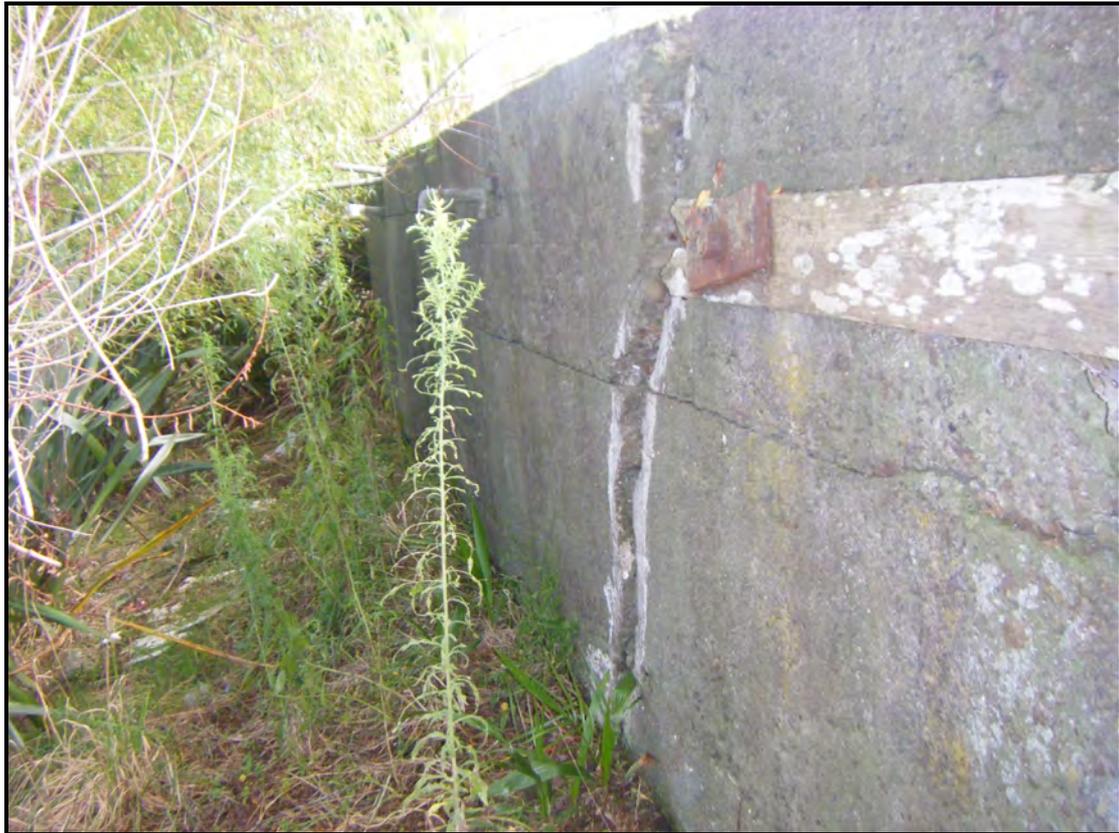
Photograph 38: Failure of concrete retaining wall adjacent to parking spaces on River Parade immediately upstream of SH2 bridge.

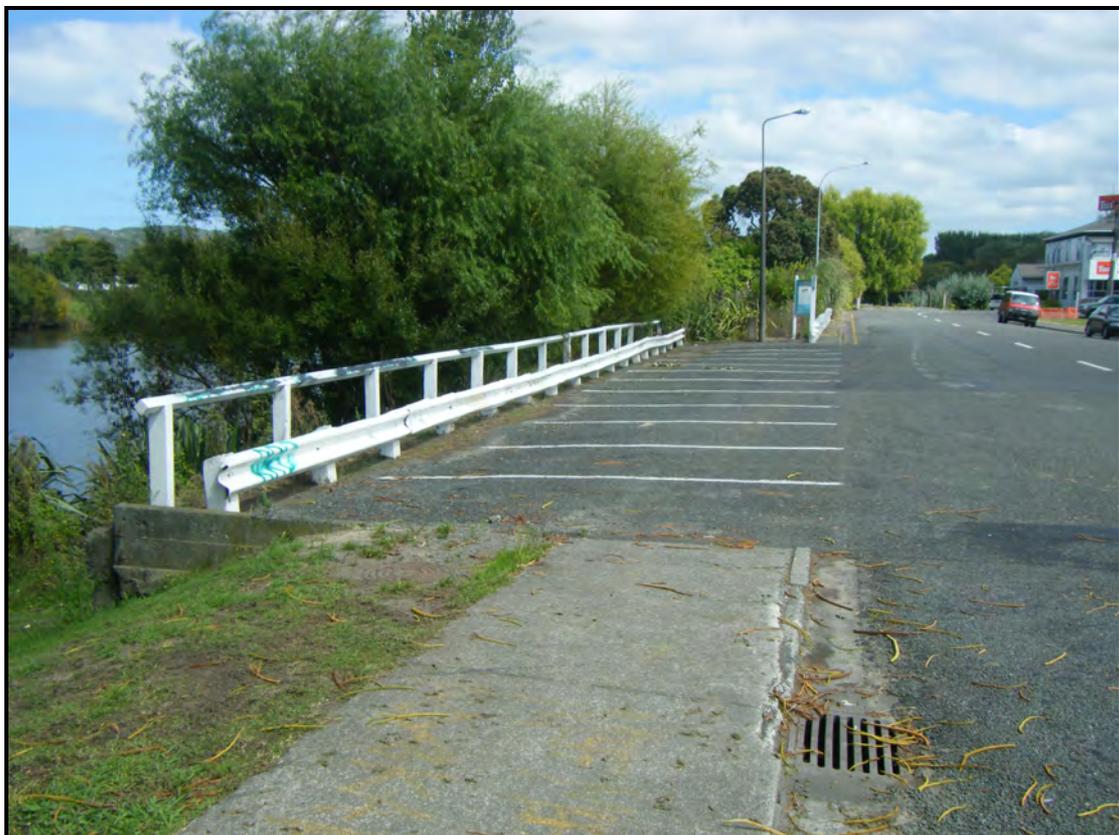
Photograph 39: Top of failed concrete retaining wall (as shown in Photograph 38 above) located along River Parade.

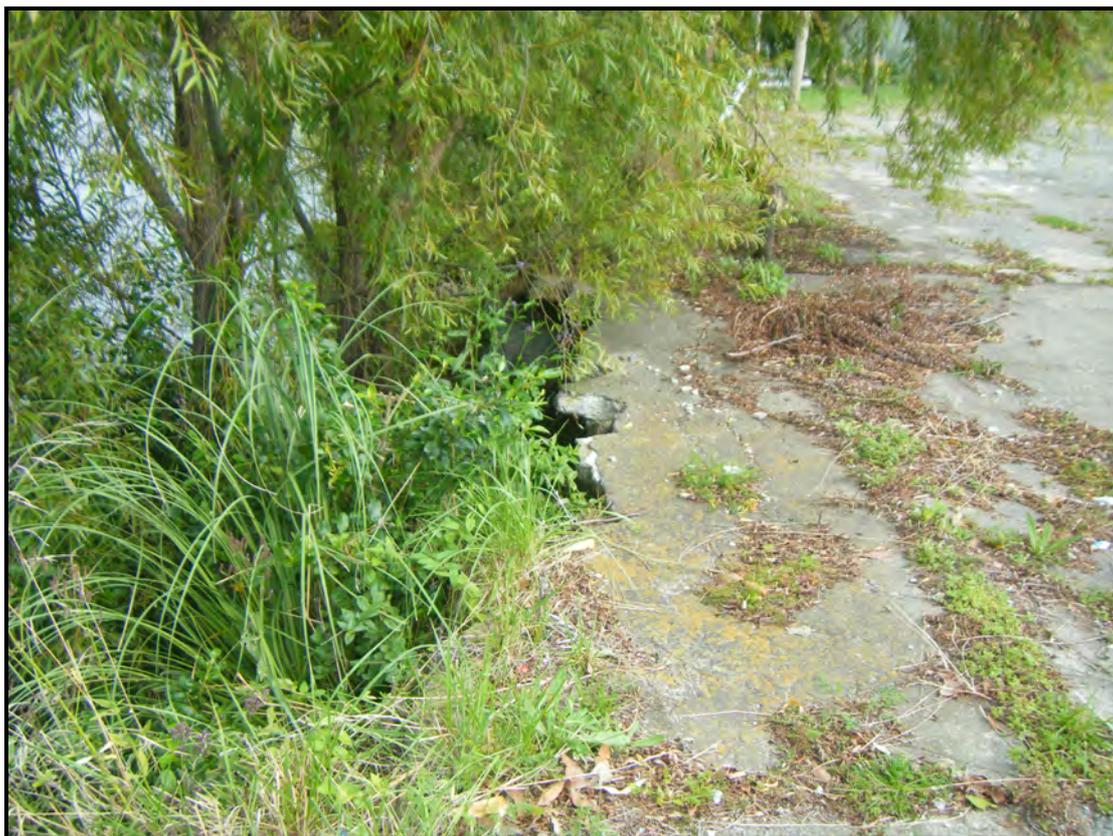
Photograph 40: Slope failure in front of former motel at western end of River Parade.

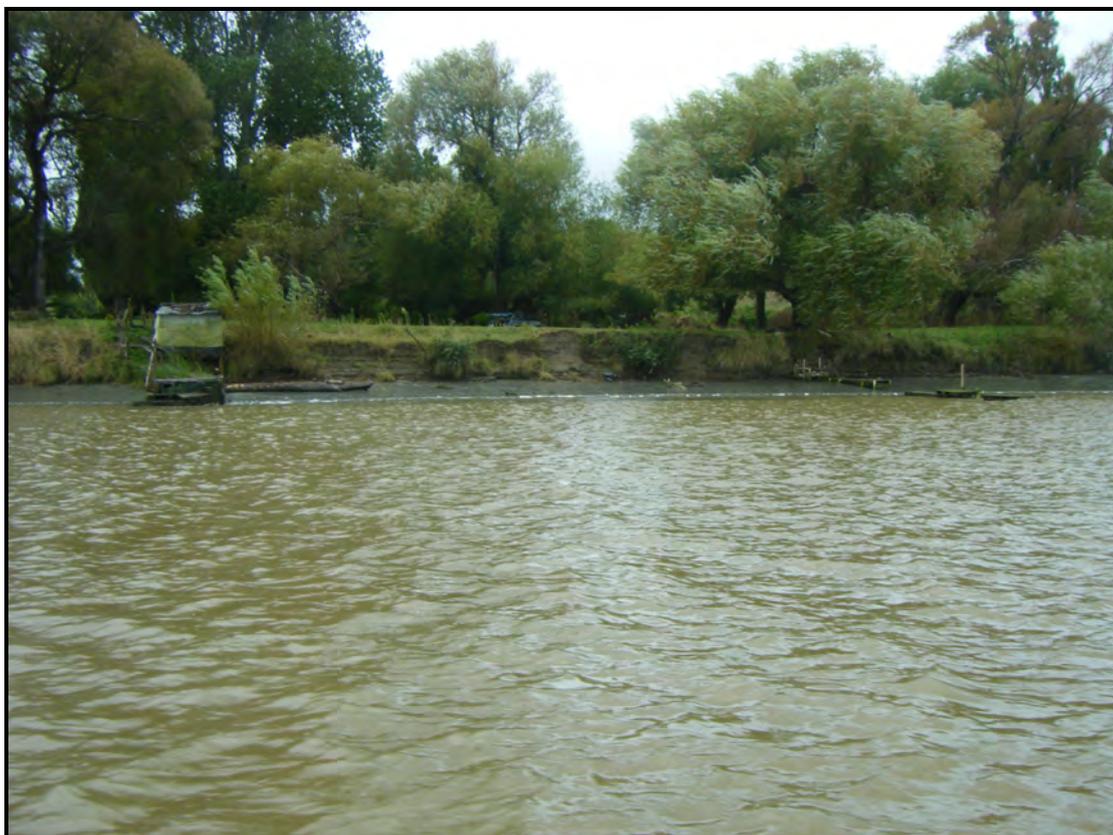
Several minor slips were observed affecting the river banks along the lower slopes (see Photograph 43). Although not apparent from the boat inspection, possibly due to the presence of dense tree cover, a large portion of the river bank downstream of the tributary that discharges into the river just downstream of Flaxmill Road, appears to constitute a large subsided area adjacent to the river. An arc extending approximately 550m along the river bank, increasing to approximately 60m back from the bank, is backed by a further 1.5 to 2.5m high slope. This is revealed by the LIDAR data and can be seen on the aerial photographs. Further detailed inspections will be required to confirm whether this is the case.

Photograph 43: Minor instability of low slopes within Section 8.
