# Chapter 9.7

## Hawke's Bay Airport

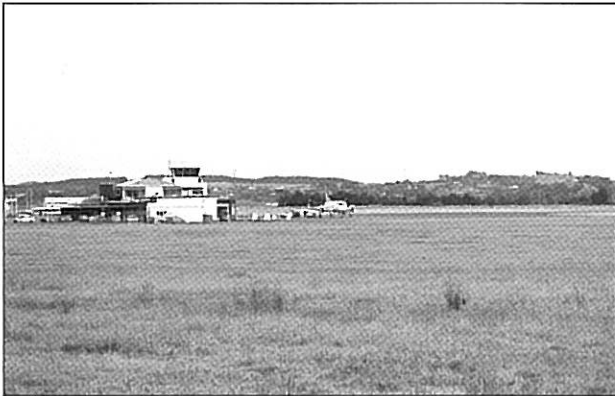
*Hawke's Bay Airport July 2001.  
(Photo courtesy of Hawke's Bay Regional Council)*
